# Concrete Construction

ITS FIRE-PROOF QUALITIES

REPORT SUBMITTED TO THE INSURANCE ENGINEER-  
ING EXPERIMENT STATION, EDWARD ATKINSON,  
DIRECTOR, ON THE CONFLAGRATION  
IN BALTIMORE.

By PROF. CHARLES L. NORTON.

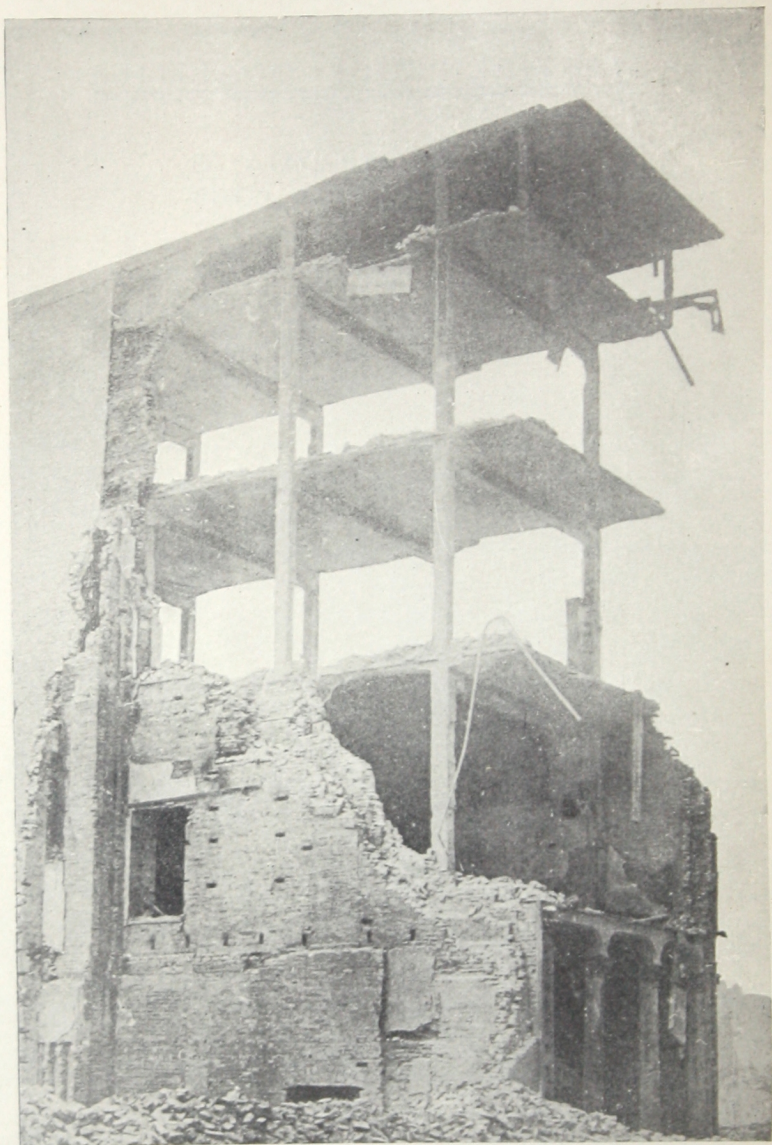
FERRO CONCRETE STRUCTURE STANDING AFTER THE FIRE.

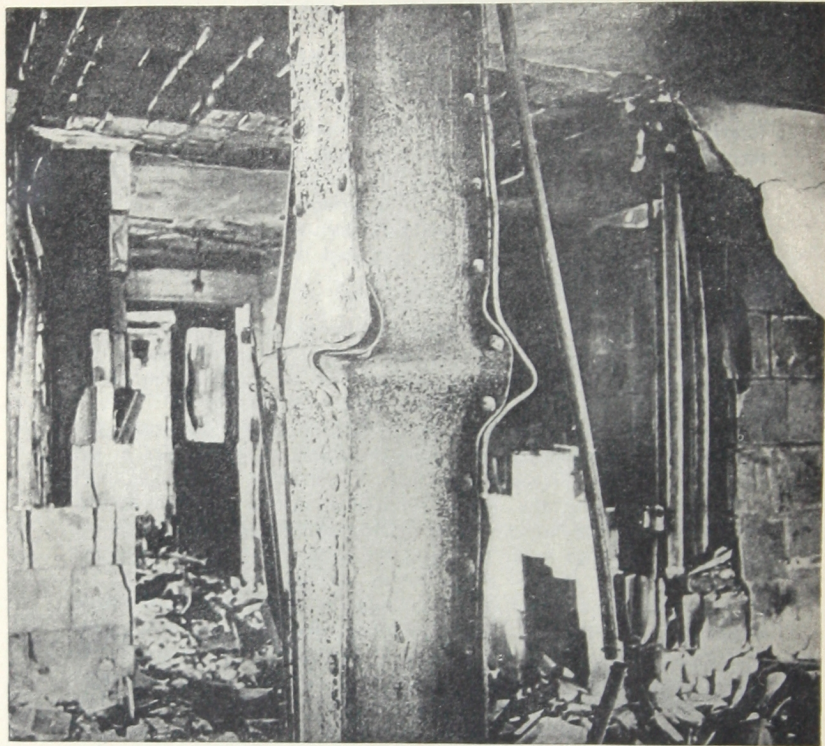
THE CRUSHED POST IN THE CALVERT BUILDING.

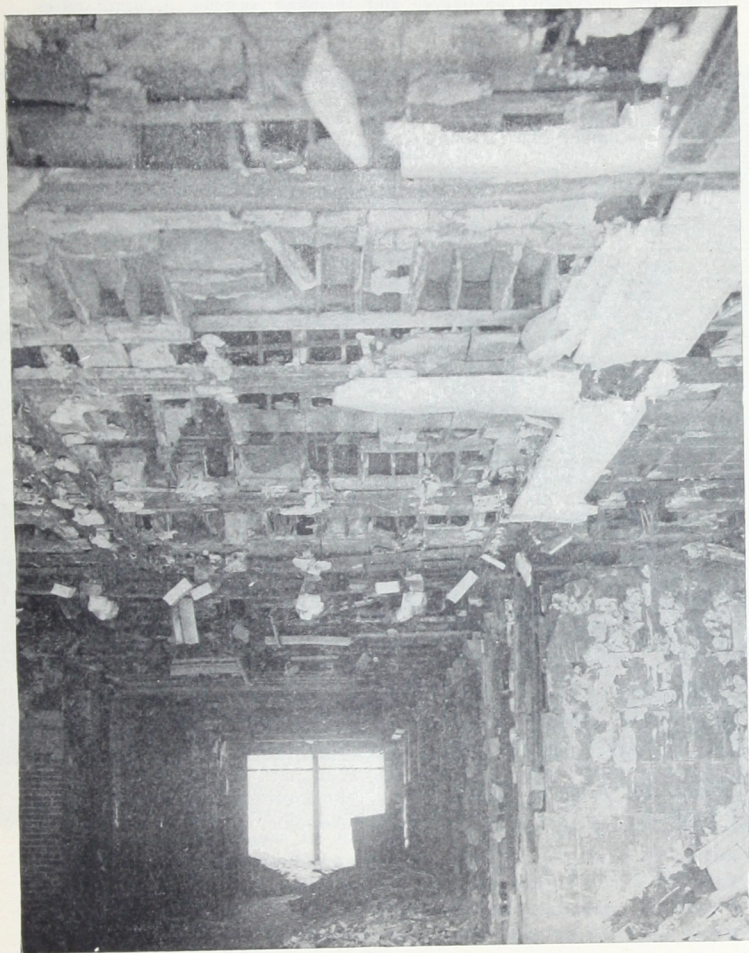
TERRA-COTTA CEILING OF THE CORRIDOR—CONTINENTAL TRUST BUILDING.

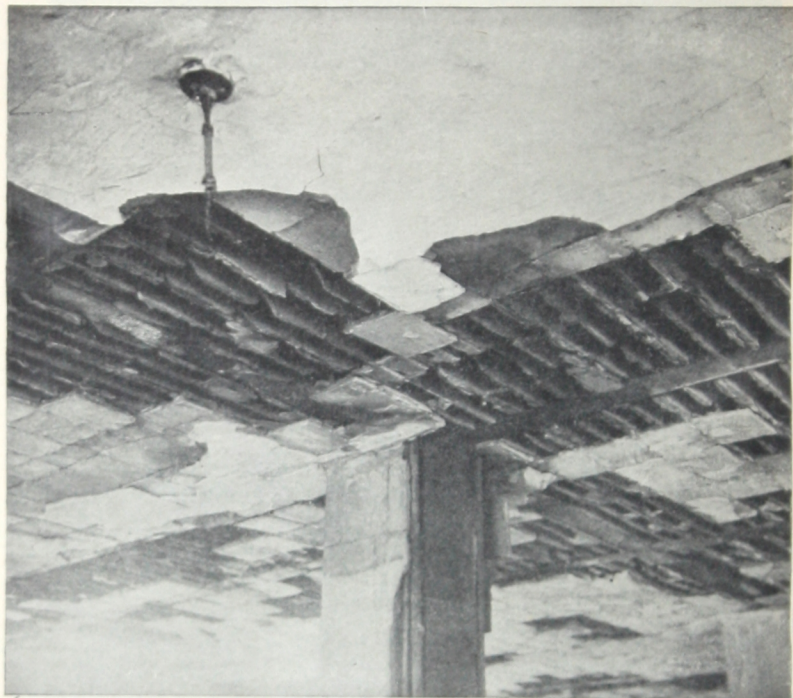
SHOWS CONDITION OF A LARGE PART OF THE TERRA-COTTA FLOOR ARCHES.

The floor arches of many different spans and of different details of construction, but in the main of terra-cotta or lime-teil, show much the same sort of distress as the partitions. The bond between the tiles is broken, quite generally, and the tiles themselves are cracked and broken

in great numbers. The lower face or soffit of the tiles has split off over large areas, and 50 per cent. or 60 per cent. of the terra-cotta floor construction will, I fear, need to be replaced or reinforced.

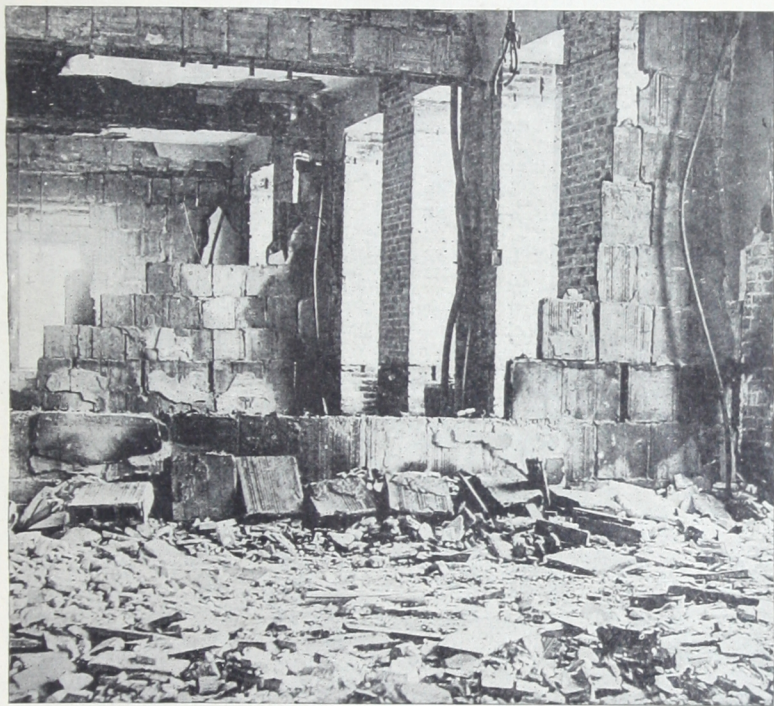
A ROOM IN THE CALVERT BUILDING, SHOWING FAILURE OF PARTITIONS.

The partitions of terra-cotta and lime-teil are very largely destroyed and the unfitness of these materials for this purpose seems clear. Many partitions have fallen and more are in such condition that they must be replaced. Much of the lime-teil is softened and the terra-cotta is cracked or broken and the bond between blocks is loosened. If metal lath partitions were in existence to any great extent, they failed as well, for few were in evidence in good order.

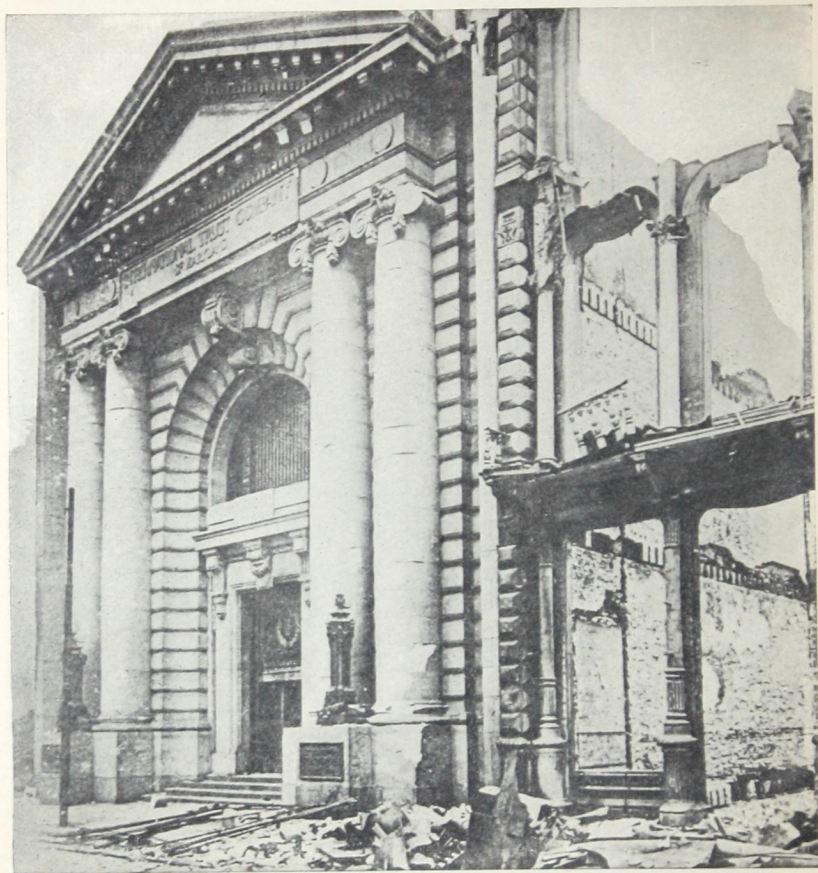
INTERNATIONAL TRUST COMPANY, IN PART CONCRETE STEEL; SKYLIGHT  
CRUSHED BY FALL OF NEIGHBORING WALLS.

Further, in the International Trust Company Building a small paper room having a Hennebique floor and ceiling, was so intensely heated that

at the end of three days the lumps of cast iron which had earlier been a copying press and an embossing stamp were still red hot, and yet neither floor nor ceiling show signs of distress. This is the more remarkable in that the walls of the adjoining building fell through the skylights

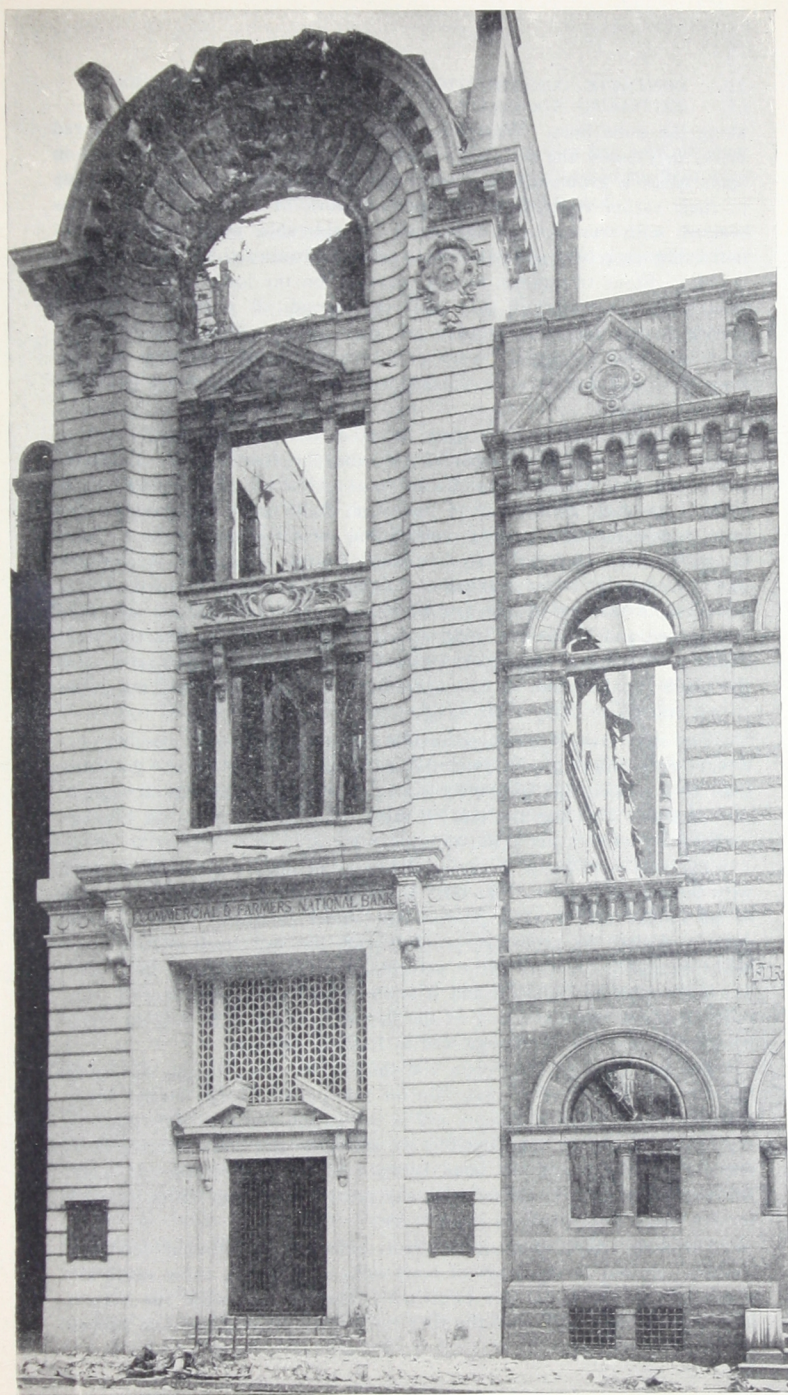
COMMERCIAL AND FARMERS' NATIONAL BANK. STONE CONCRETE BELOW  
BANK ROOM, WOODEN CONSTRUCTION ABOVE.

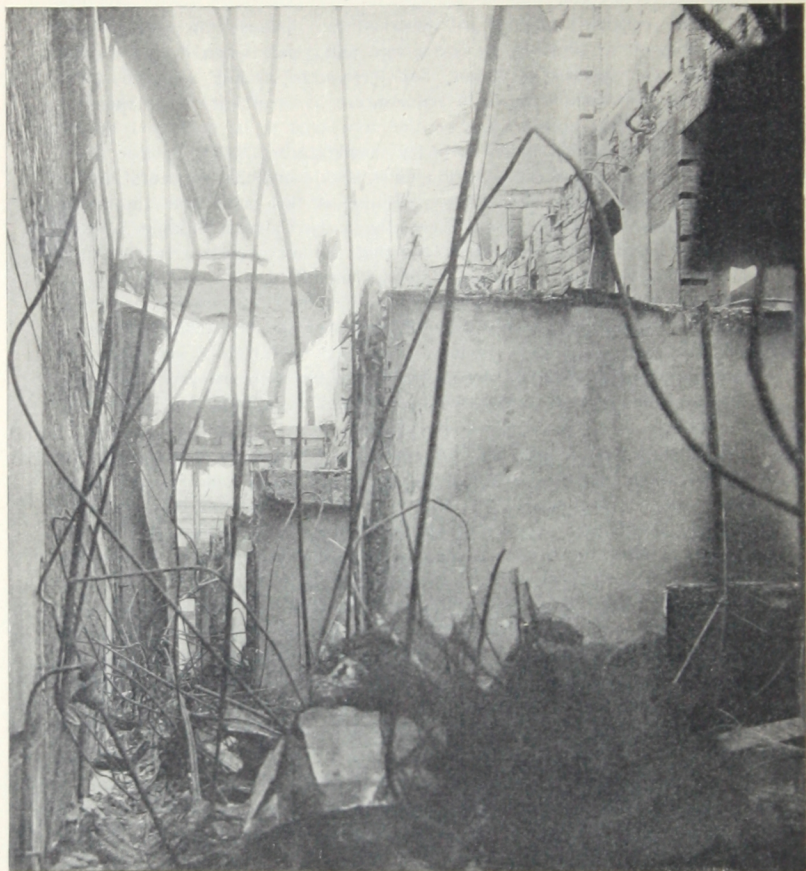
VIEW ABOVE CONCRETE FLOOR OF COMMERCIAL AND FARMERS' NATIONAL BANK,  
SHOWING DESTRUCTION OF BUILDING AND CONTENTS.

upon the Hennebique floor. There were in the Commercial and Farmers' National Bank and in the National Bank of Commerce concrete floors, which stood the fire test well.

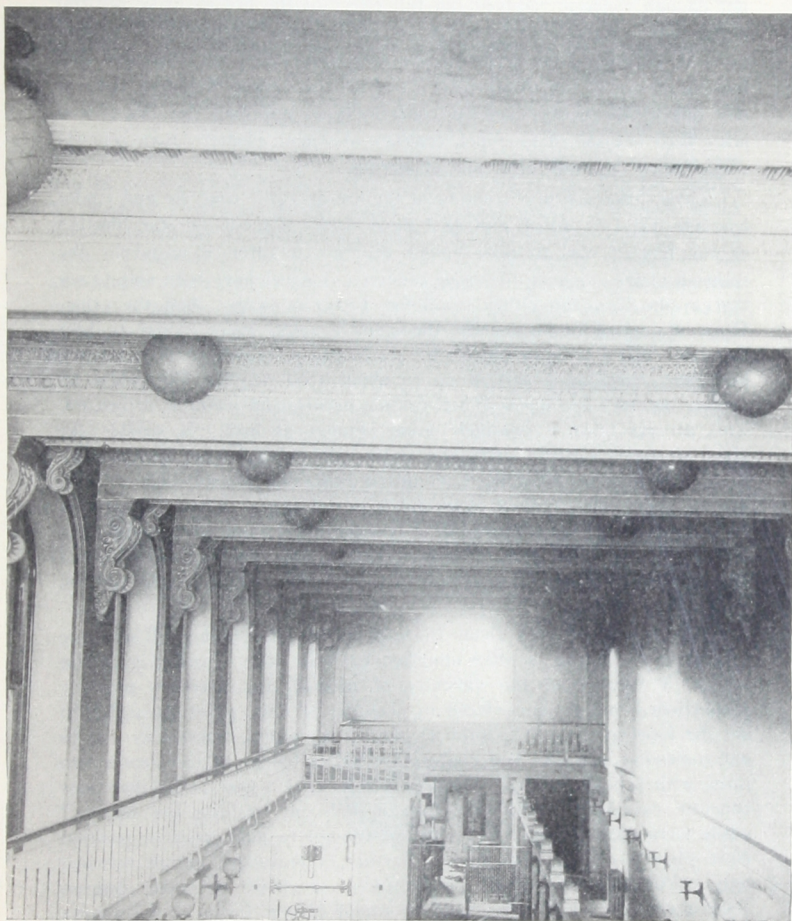
VIEW OF ROOM BELOW THE CONCRETE FLOOR IN THE COMMERCIAL AND FARMERS' NATIONAL BANK.
